safer roads for everyone

Pedestrian Guardrail - Taking it Away

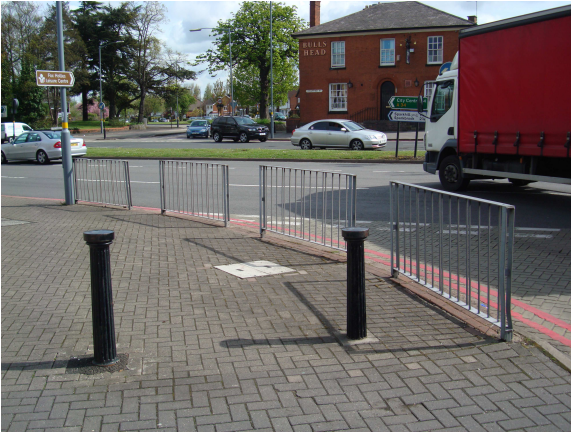
The intended purpose of some guardrail is unclear

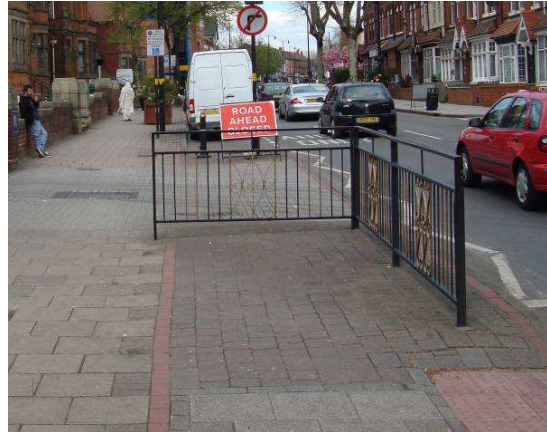
Perhaps sometimes it is meant to be decorative?

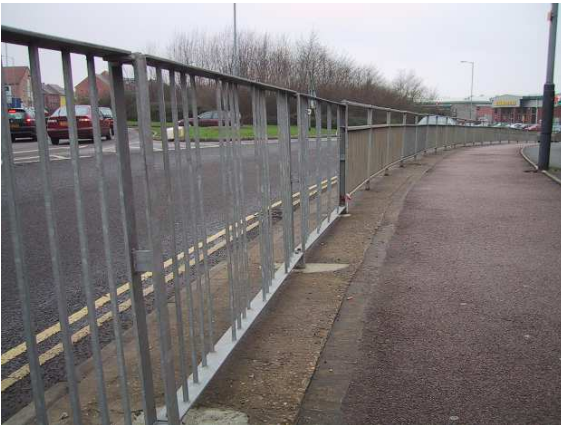
An example of unsightly and excessive guardrail

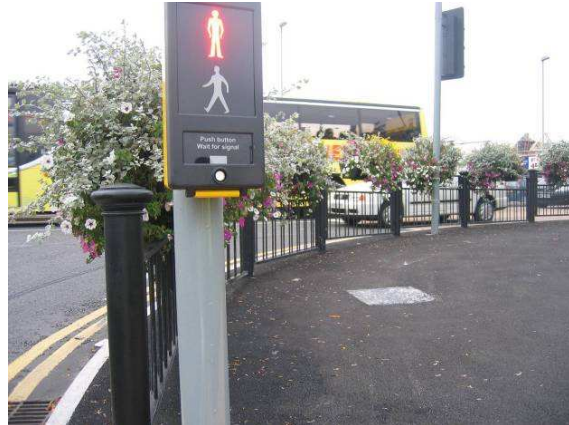
Attempts to make guardrail less unsightly have led to a different potential safety problem

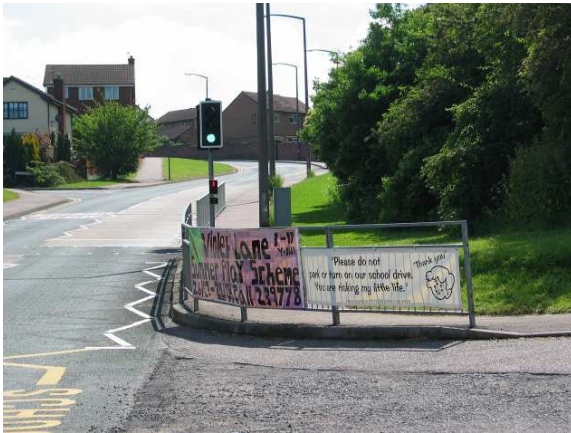
Sometimes an alternative use can be found locally

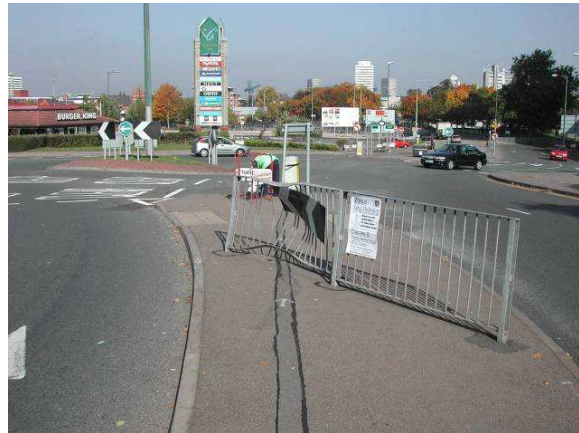
Whether this protected a pedestrian is uncertain

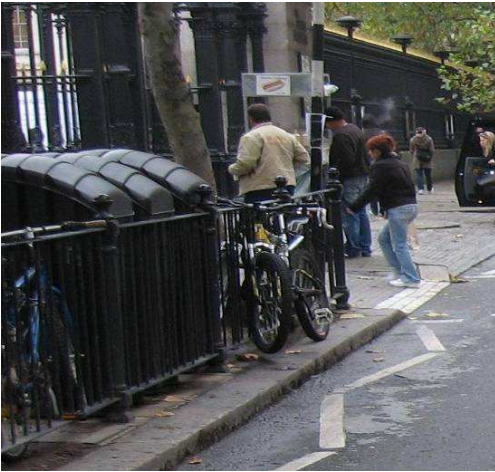
A different Borough, but a typical example of cycles and bins being locked to guardrails

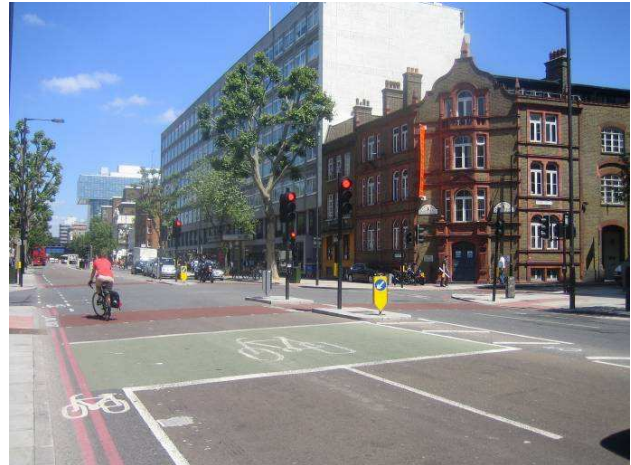
Another Borough, where a signal junction has been re-modelled with no guardrail

The complete removal of guardrail at the type of site illustrated above should only take place following a more comprehensive assessment using the DfT/TfL guidance methodology.
